## Courthouse mural getting new look

By FRANK L. WERTZ II  
DAILY GAZETTE staff writer

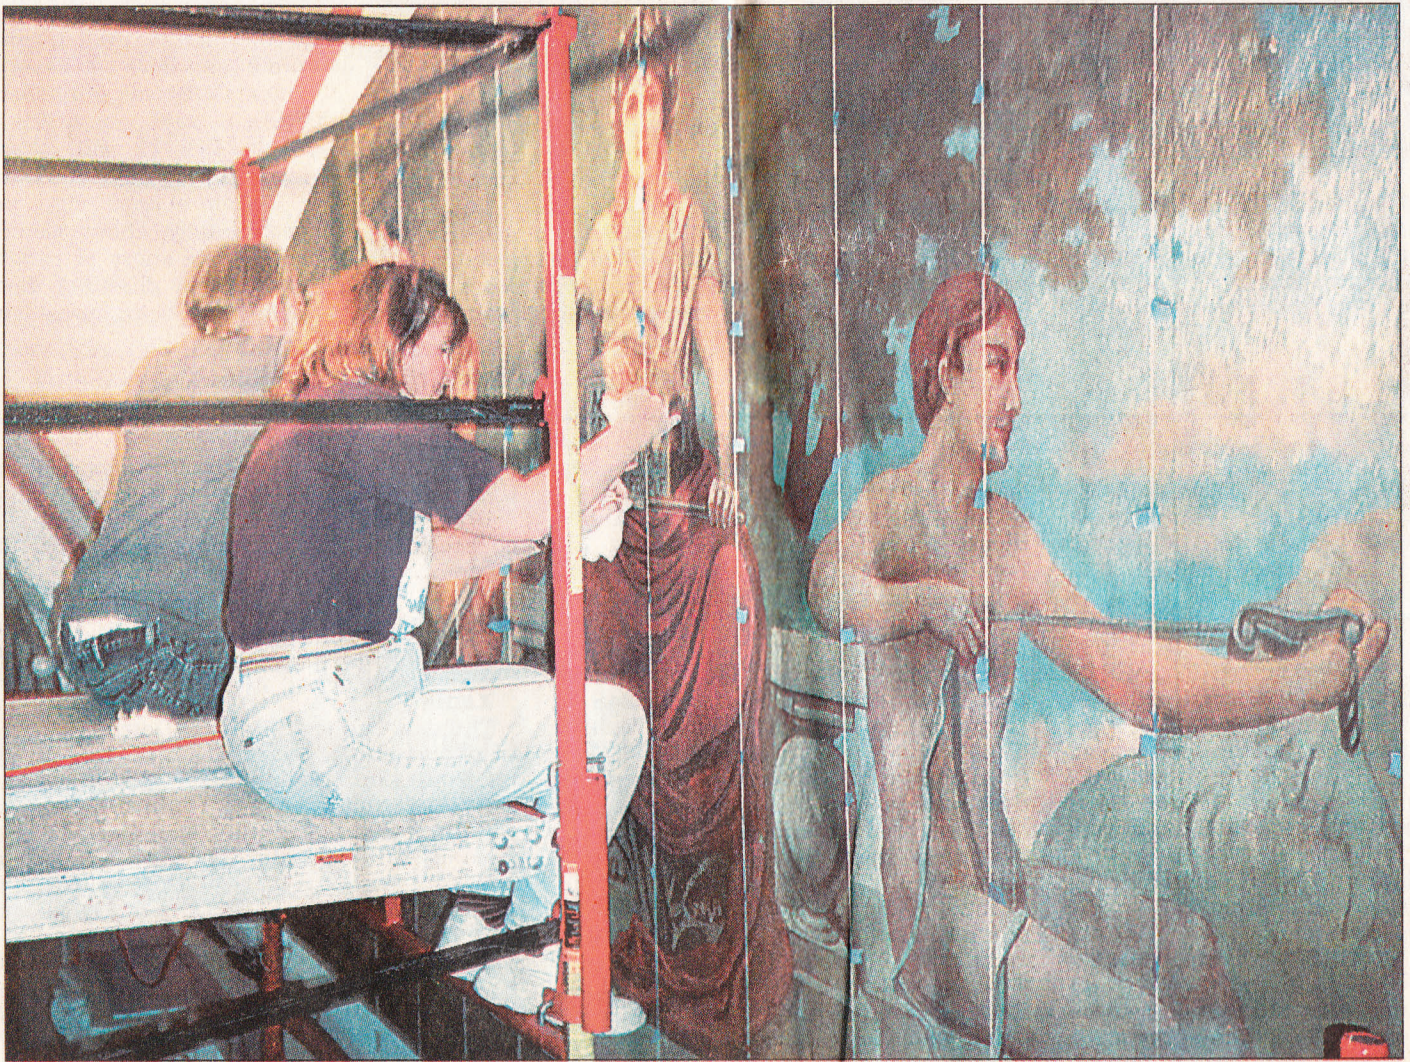
Nancy Achberger of Milford uses a syringe to inject an adhesive behind an air pocket in the paint of this mural on the second floor of the Greene County Courthouse. Achberger and three other artists, including John Babcock who is in the background, are renovating the mural.

First, an ordinary syringe is filled with a heat-activated adhesive. The adhesive is applied behind any air pockets that have formed in the paint and where there are cracks in the paint.

Heat is applied to the mural in a process that is like ironing. It not only flattens out the air pockets, but the paint is also glued to the wall.

After the mural is thoroughly clean, the painting is isolated with a varnish. Then the artists can replace the missing areas with the paint. They must match the painting's texture and colors.
